Inspection Report

Minerals Regulatory Program

Mine Name: Torrey Red and Buff Quarries

Permit number: S0550021

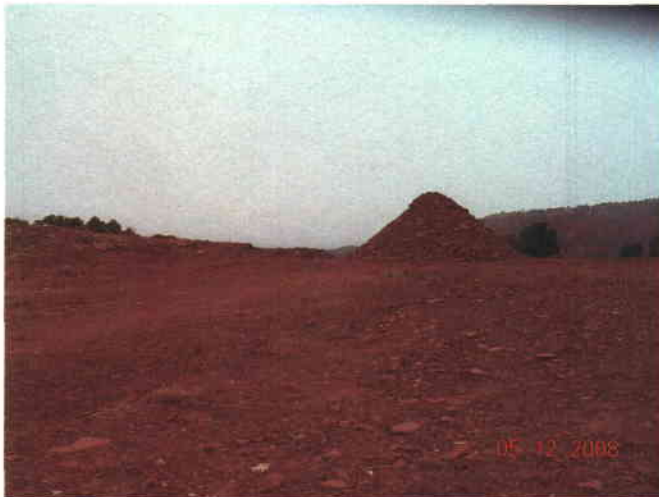
The loading/processing area was seeded in the fall of 2004, and despite a very wet winter and spring, there was little germination. The area still has little vegetation, not even weeds. This baffles me because the soil reports do not show any problems with the possible exception of texture: it is a clay loam. My suggestions are stated below.

Photo 1. The processing area that was seeded in 2004.

The operator should try to reseed the processing/loading area again this fall. I would like to see the area left very rough to see if the increased water holding ability would increase the amount of germination and establishment.

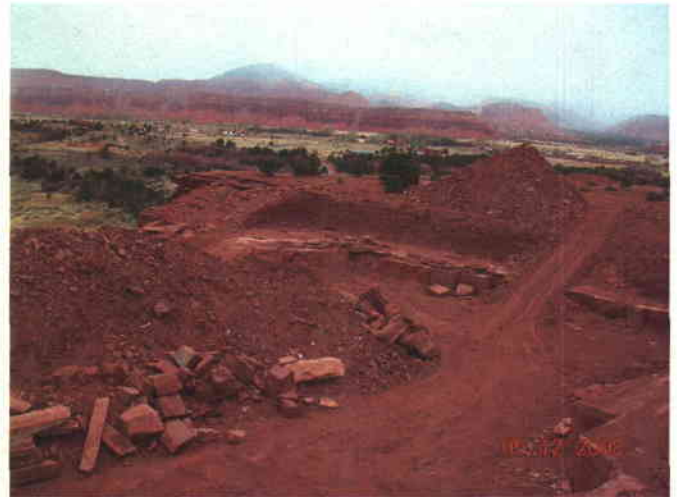
Photo 3.

Photo 2. Photos 2-4 show various views of the quarry.

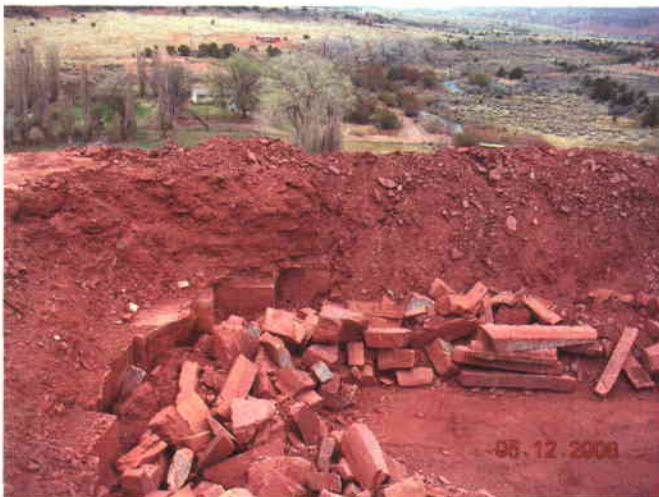
It appeared the operator has done some recent quarrying but not a lot.
